NATIONAL TRANSPORTATION SAFETY BOARD

RAILROAD ACCIDENT REPORT

DERAILMENT OF RINGLING BROS. AND
BARNUM & BAILEY CIRCUS BLUE TRAIN
NEAR LAKELAND, FLORIDA
JANUARY 13, 1994

Adopted: February 14, 1995
Notation 6321A

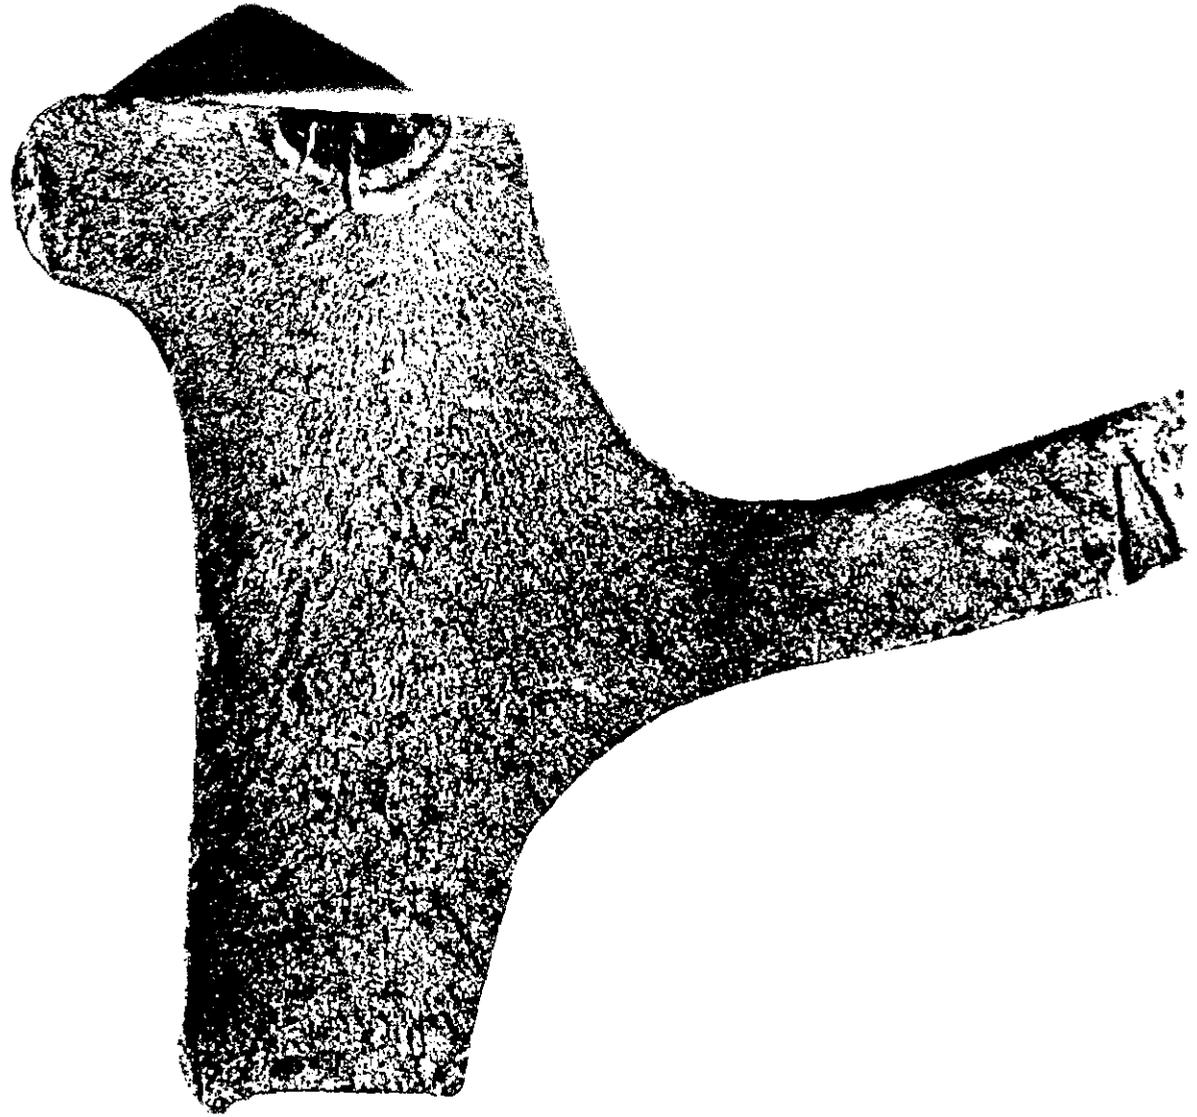
Figure 4 is a low magnification view of the fracture face and figure 5 is a close up view of the fatigue fracture zone on the removed section of the wheel. Examination with the aid of a low power binocular microscope revealed that the fatigue cracking initiated from multiple sites, as indicated by the brackets in figure 5. Examination further revealed that a portion of the fatigue zone adjacent to the fracture origin areas was covered with a dark corrosion product.

Figure 4 Low magnification direct view of the fracture face shown in figure 3a.

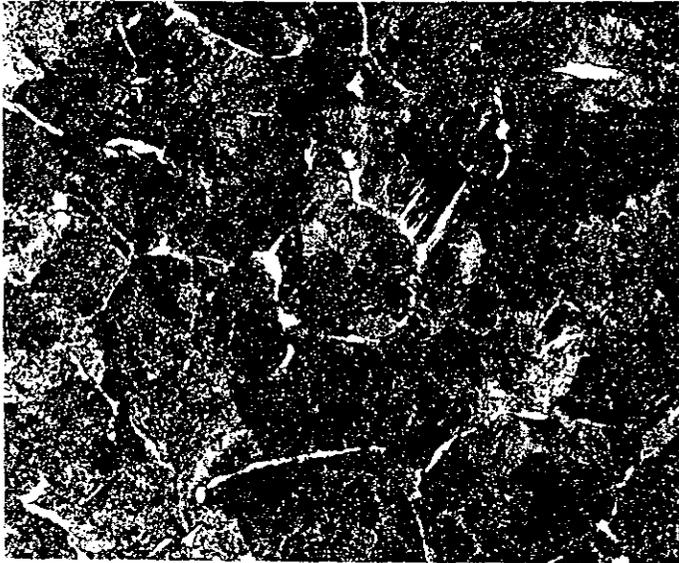
Photomicrographs **a**, **b**, **c**, and **d** in figure 8 denote the typical differing microstructures in the areas of the tread specimen. The base material (see arrow "a" in figure 7) consisted of fine pearlite (dark areas) with some grain boundary ferrite (light areas). In the area denoted by arrow "b" in figure 7 the pearlite was partially spheroidized into carbides. The

Figure 8 Typical microstructures in the areas denoted by arrows "a", "b", "c", and "d" of figure 7 Etch - 2% nital, magnification - 500X

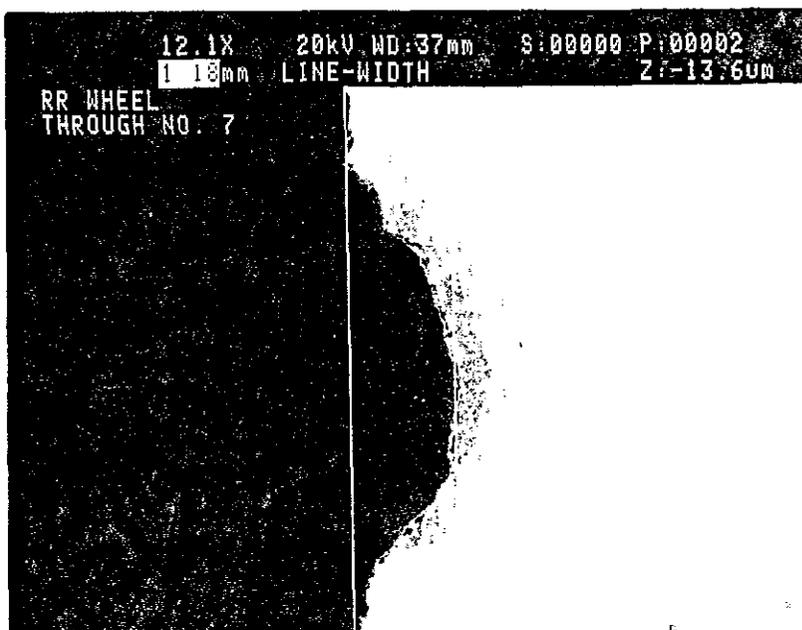
polished and etched specimen revealed a decarburized layer underlying this stamp. The microstructure and depth of the decarburized zone appeared to be similar to that found for the stamped numerical character 4. Figure 11 is an SEM photomicrograph showing that at the measured location the depth of the stamped 7 was 0.045 inch (1.18 mm).

Figure 11 SEM photograph showing the depth of the stamped numerical character "7" in the separated wheel (between the two vertical white lines)
